THIRD ENDORSEMENT on VF-51 AAR ser 4-56 concerning FJ-3M BUNO 136146
accident occurring 29 October 1956, pilot SCHMOOK

FIRST ENDORSEMENT on VF-51 AAR 4-56 concerning FJ-3M BuNo. 136146
accident on 29 October 1956, pilot SCHMOOK

AIRCRAFT ACCIDENT REPORT

Part V The Accident

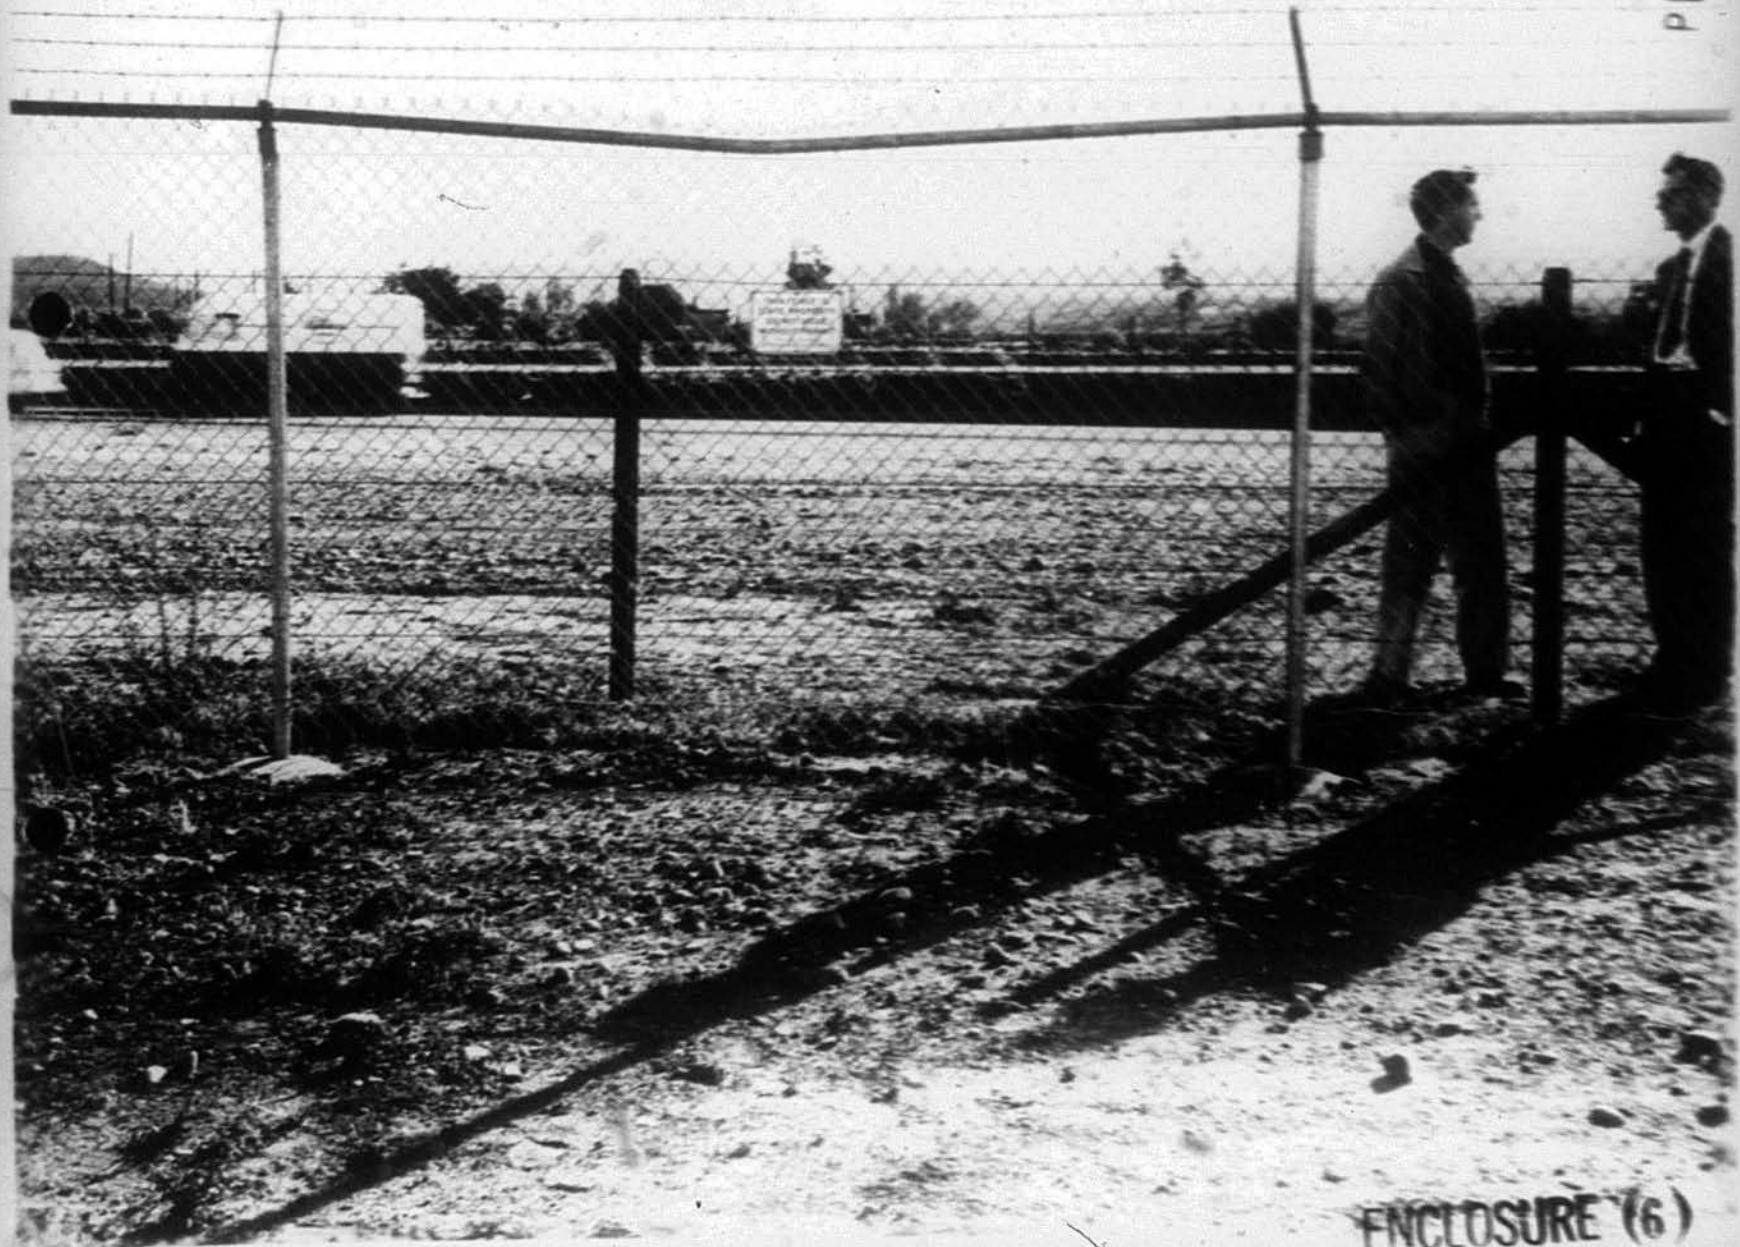
PHOTO 1

FJ-3H BUNO. 136146 sustained strike damage. Initial contact occurred when the port wing tip struck the boundary fence at NAS Miramar. Slight damage to the fence indicates that superficial damage was sustained by initial contact. The port wing received substantial damage when, thirty-six (36) feet west of the fence, it struck the ground, dragging the wing tip for 60 feet. The aircraft cocked 40° to port in relation to the direction of travel due to the drag induced by the port wing tip making contact with the ground. The degree of damage sustained by the main landing gear during this phase is undetermined, however, the main landing gear was still intact, and the nose gear was collapsing when the aircraft struck an automobile 280 feet west of the boundary fence. The vertical stabilizer was sheared off when contact was made with telephone cables 12 feet 9 inches above the ground. It is estimated the vertical stabilizer struck the telephone cables at the same time the starboard wing and drop tank struck the automobile at an estimated airspeed of 115 knots. Impact with the automobile caused immediate explosion and fire. The entire wing assembly, starboard gear and starboard drop tank separated from the fuselage upon impact. The fuselage and wing assembly veered 20° to the port after striking the automobile. The fuselage made one complete roll following the impact; in the inverted position the canopy, ejection seat and cockpit made violent contact with the ground demolishing the canopy, tearing off the top of the ejection seat and causing fatal injury to the pilot.

FIRST POINT OF IMPACT
PORT WINGTIP HIT FENCE

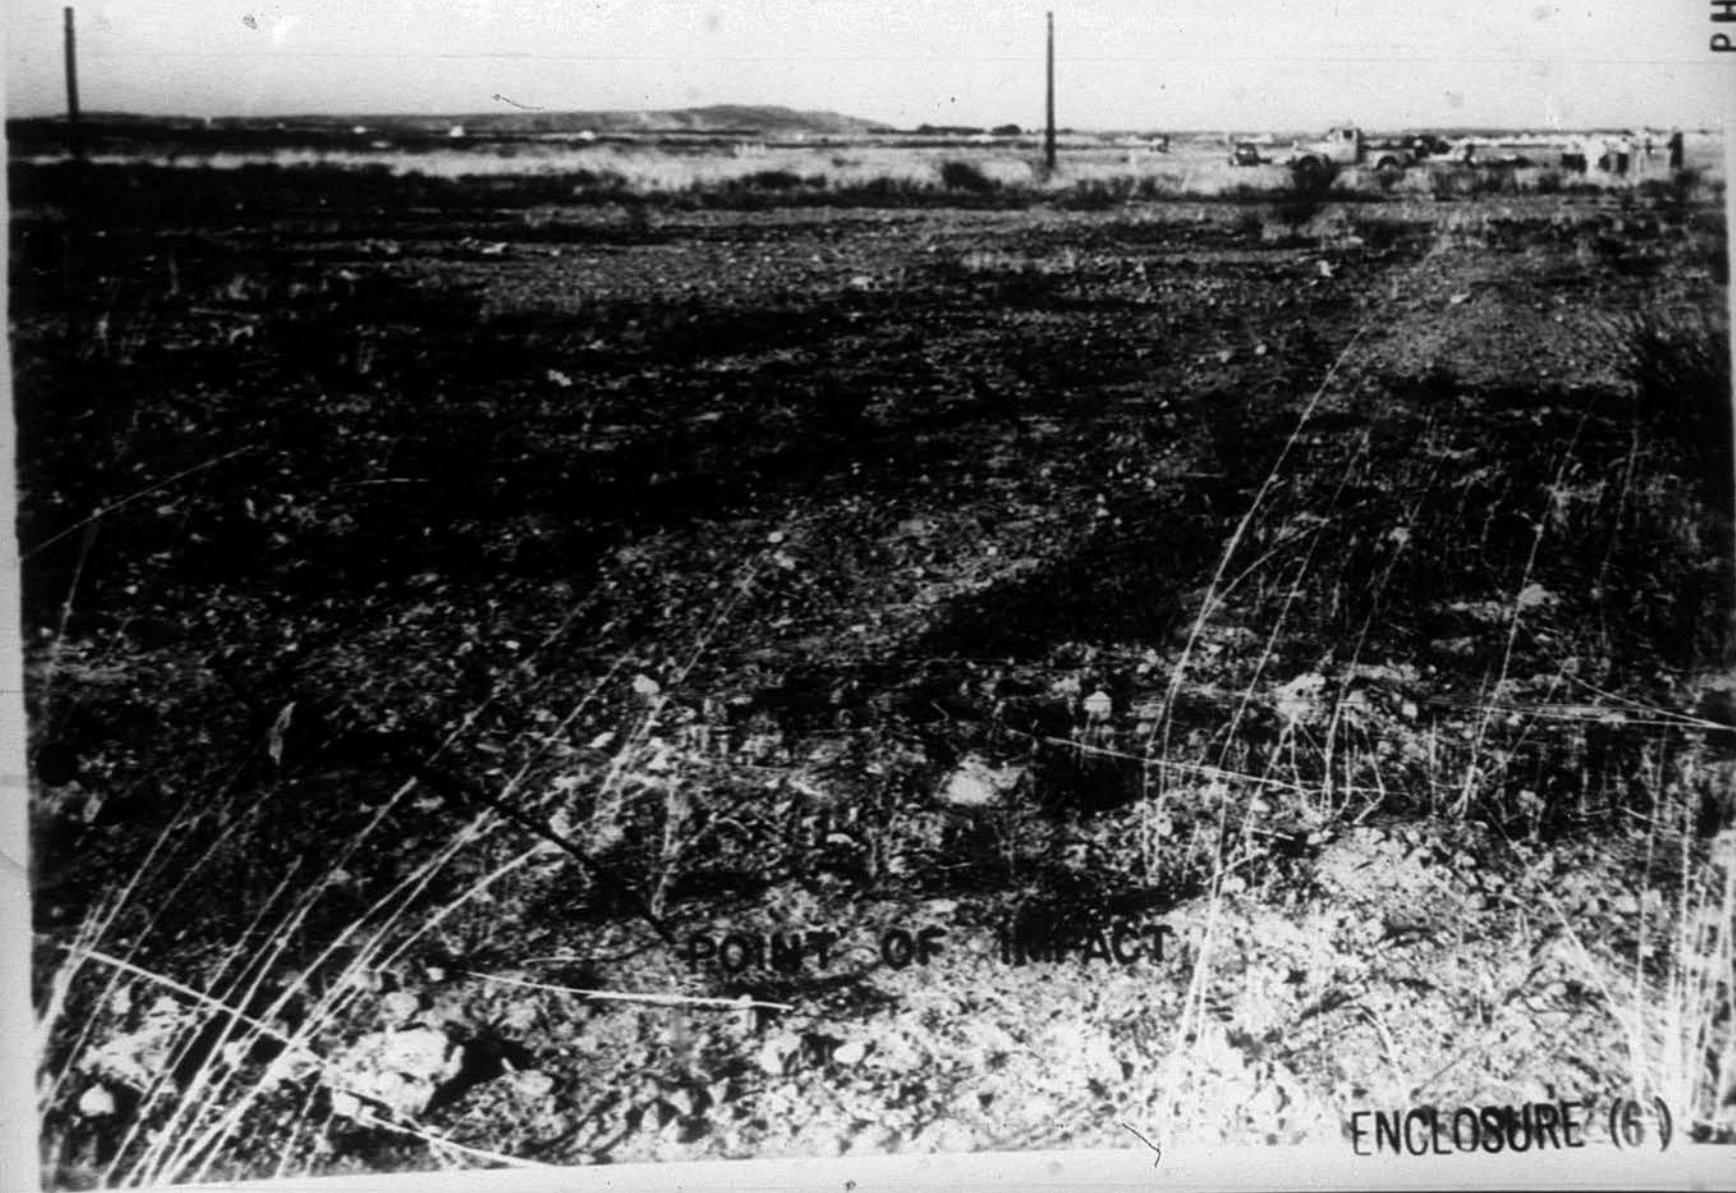
PHOTO 2

FIRST IMPACT WITH GROUND
PORT WINGTIP DRAGGED 60 Ft.

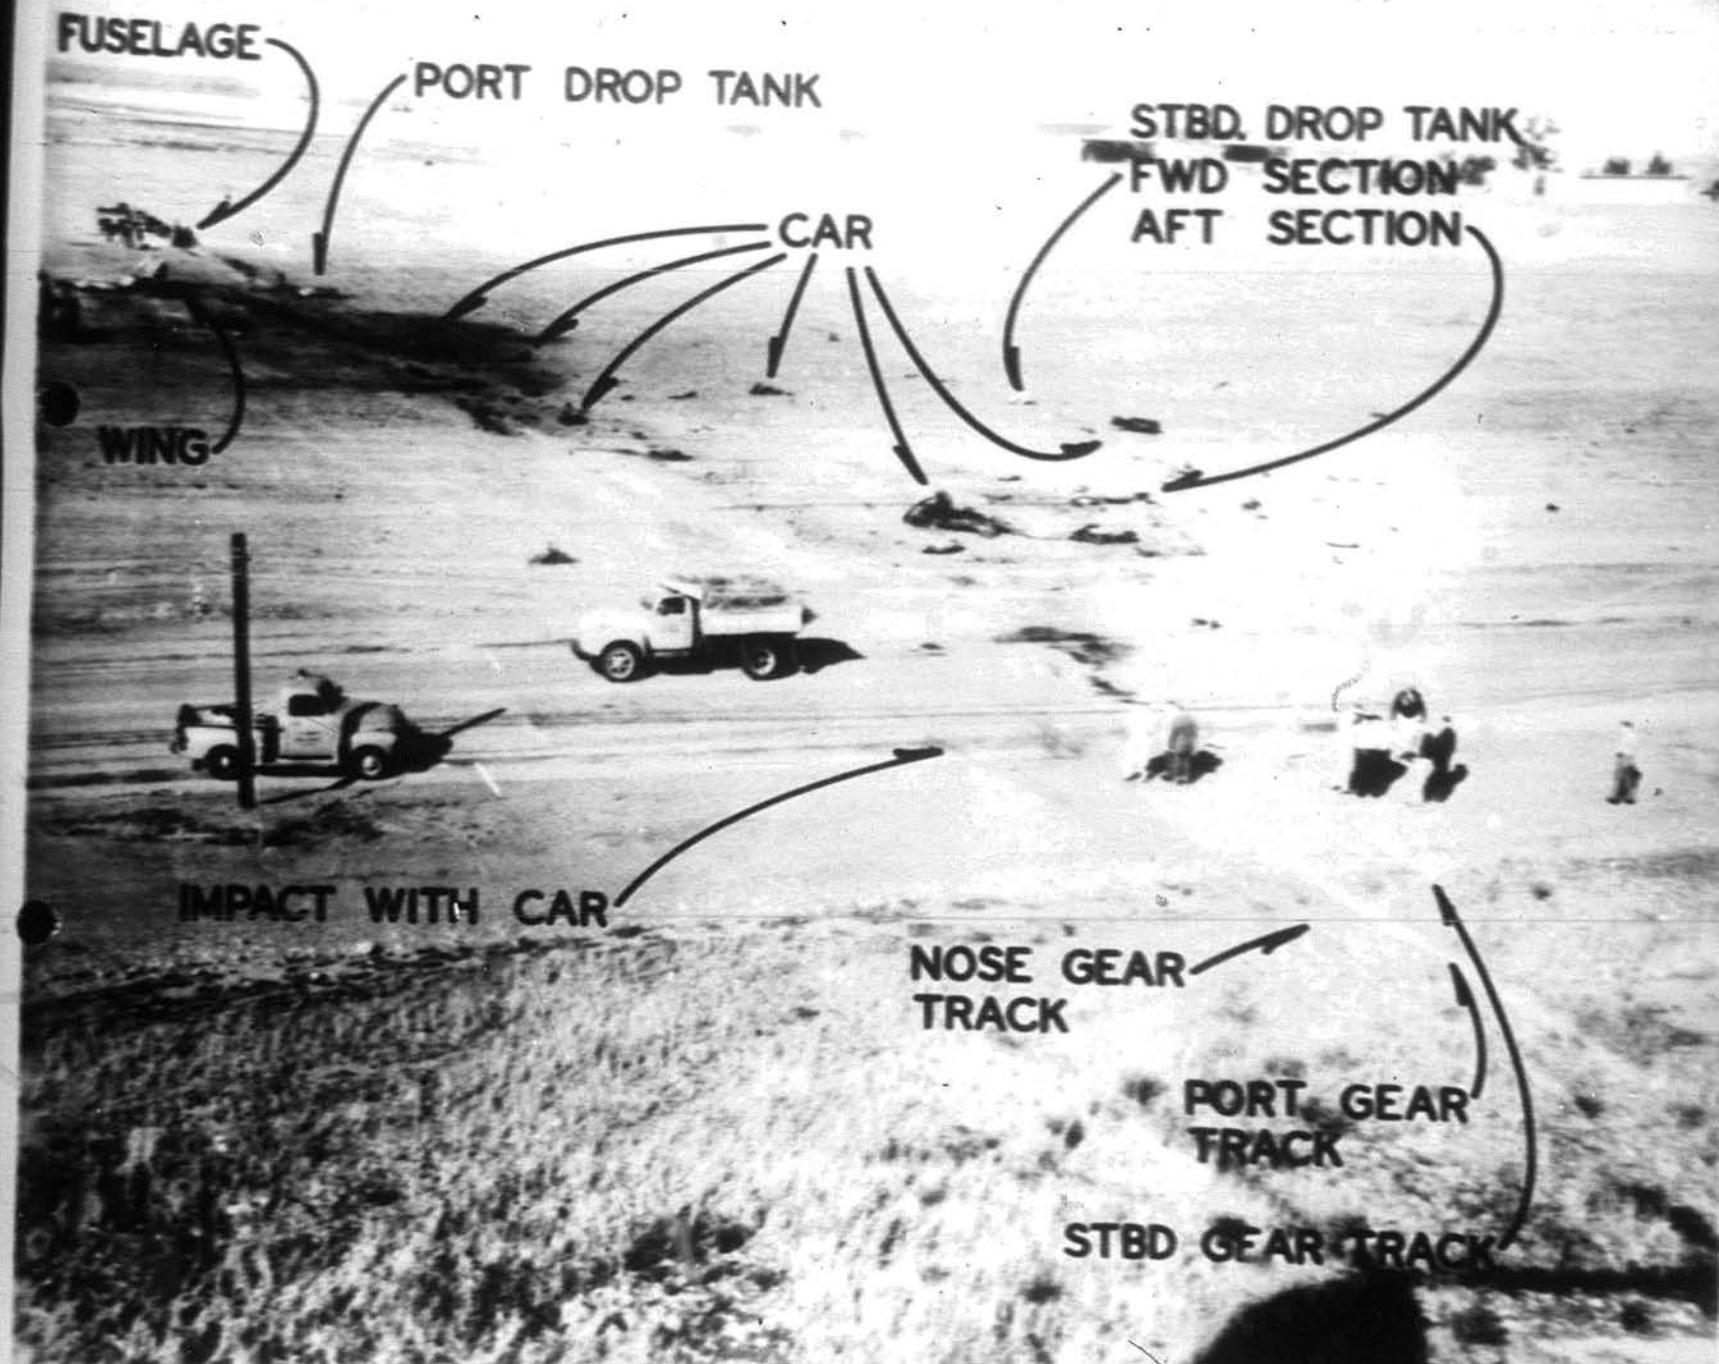
PH01, 6

after striking the automobile. While inverted during the roll, the canopy and top of the ejection seat were torn from the fuselage (Photo #6). At this time the pilot received fatal injuries.

No amount of present survival equipment would have prevented the pilot from sustaining the injuries he sustained. The forces which caused the extensive damage to the ejection seat top and canopy section were extreme.

Because of the shearing action caused by the fuselage rolling to the right and the forward motion of the fuselage, the right side of the ejection seat was so bent as to cause the lap belt mechanism to fire.

TOP OF EJECTION SEAT
GROUND OFF

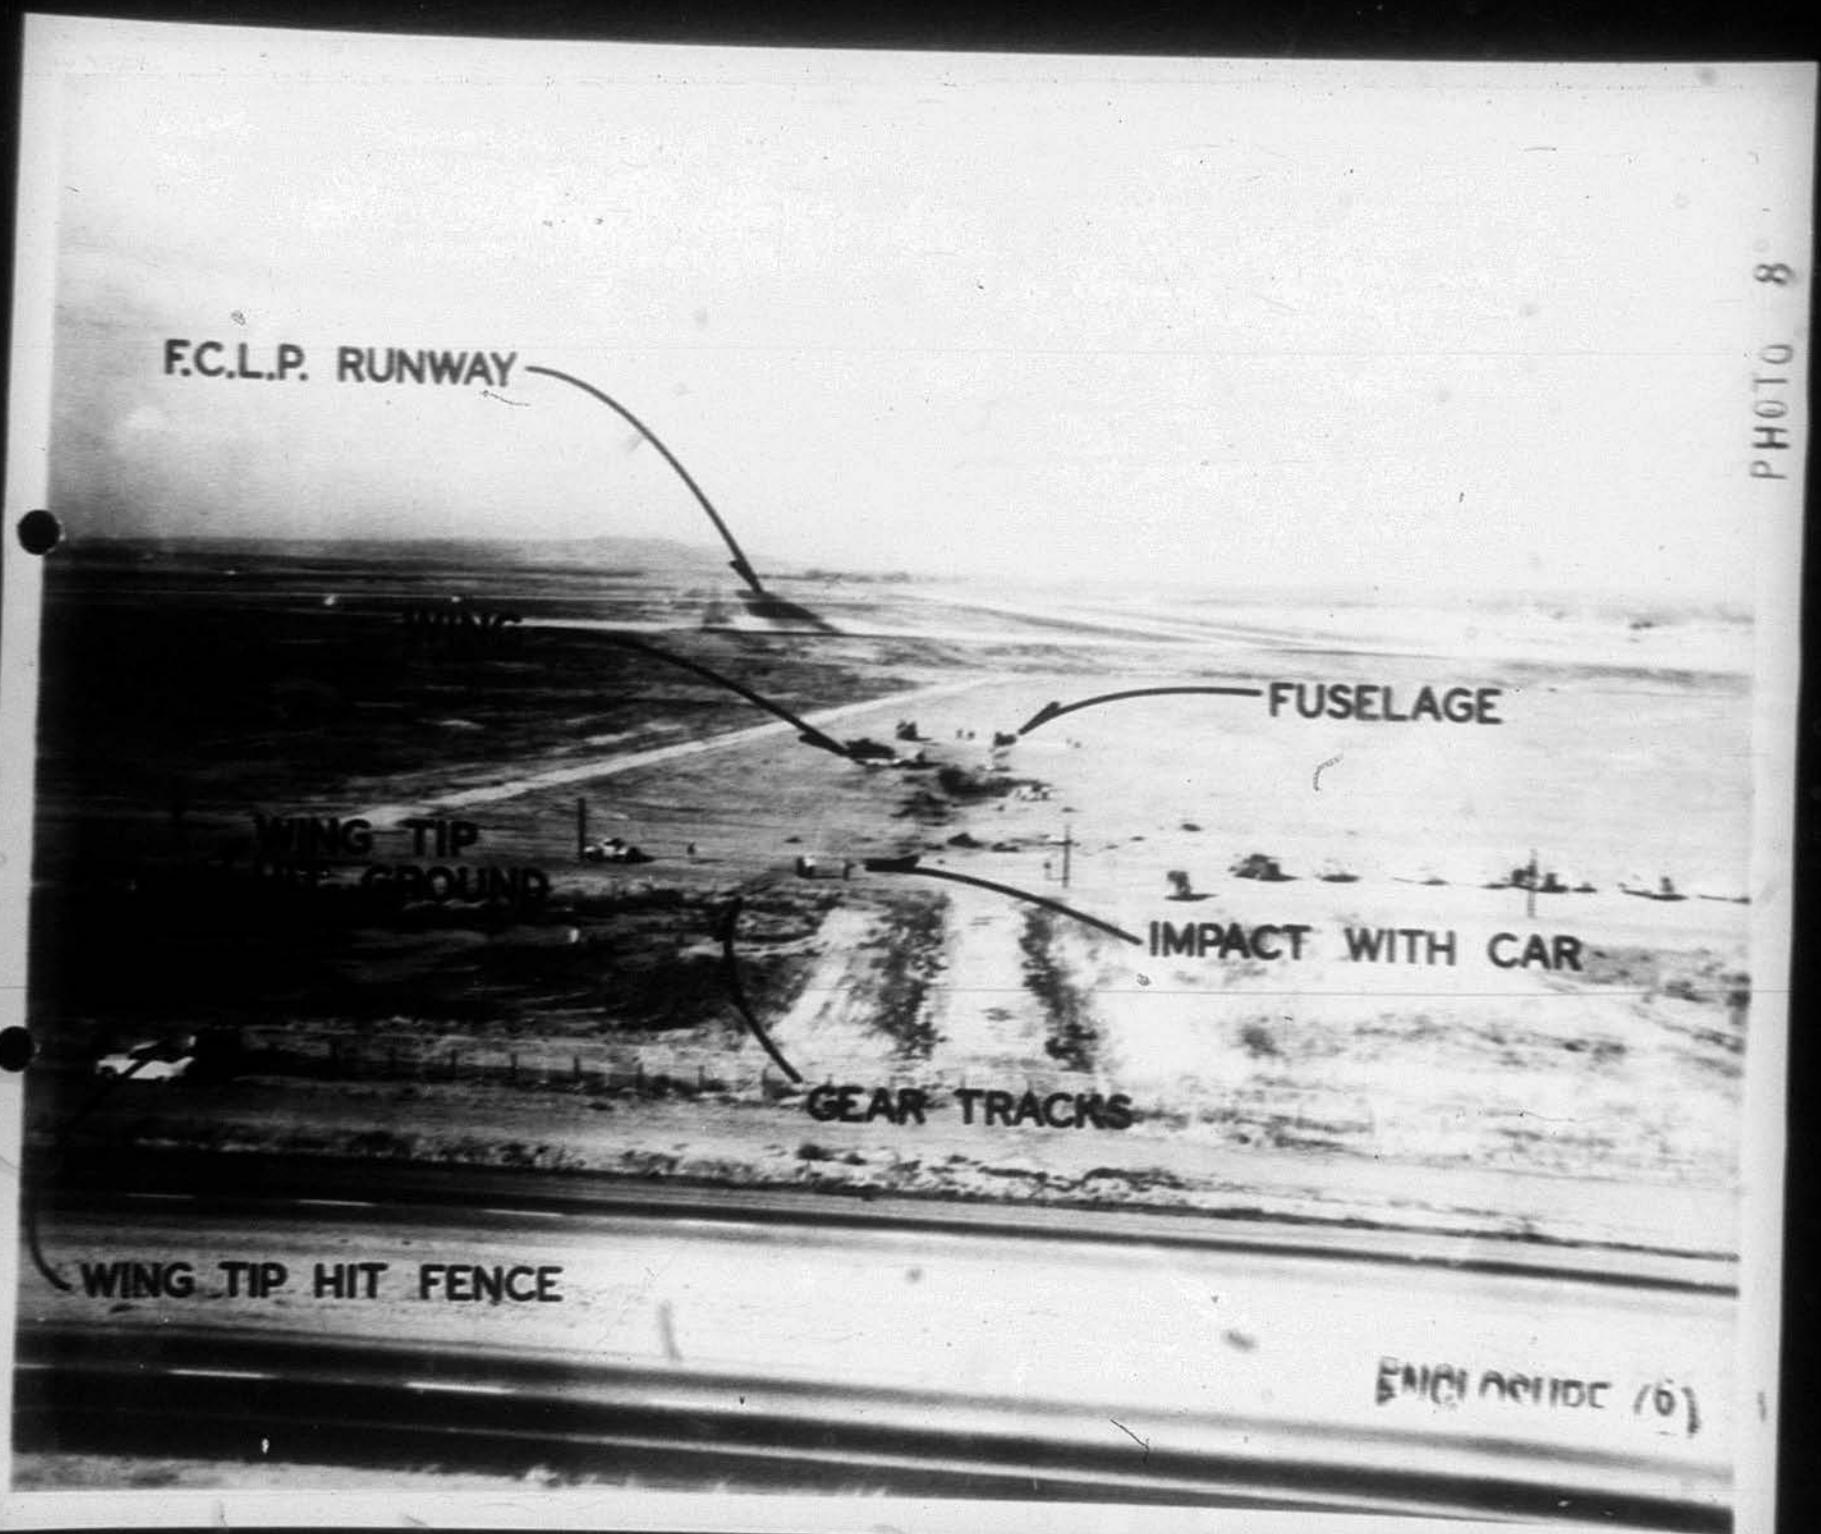
PHOTO 8

FLIGHT PATH OF AIRCRAFT
